NextEra Energy Transmission New York, Inc.

Empire State Line

Appendix K

Drainage Line Repair Plan

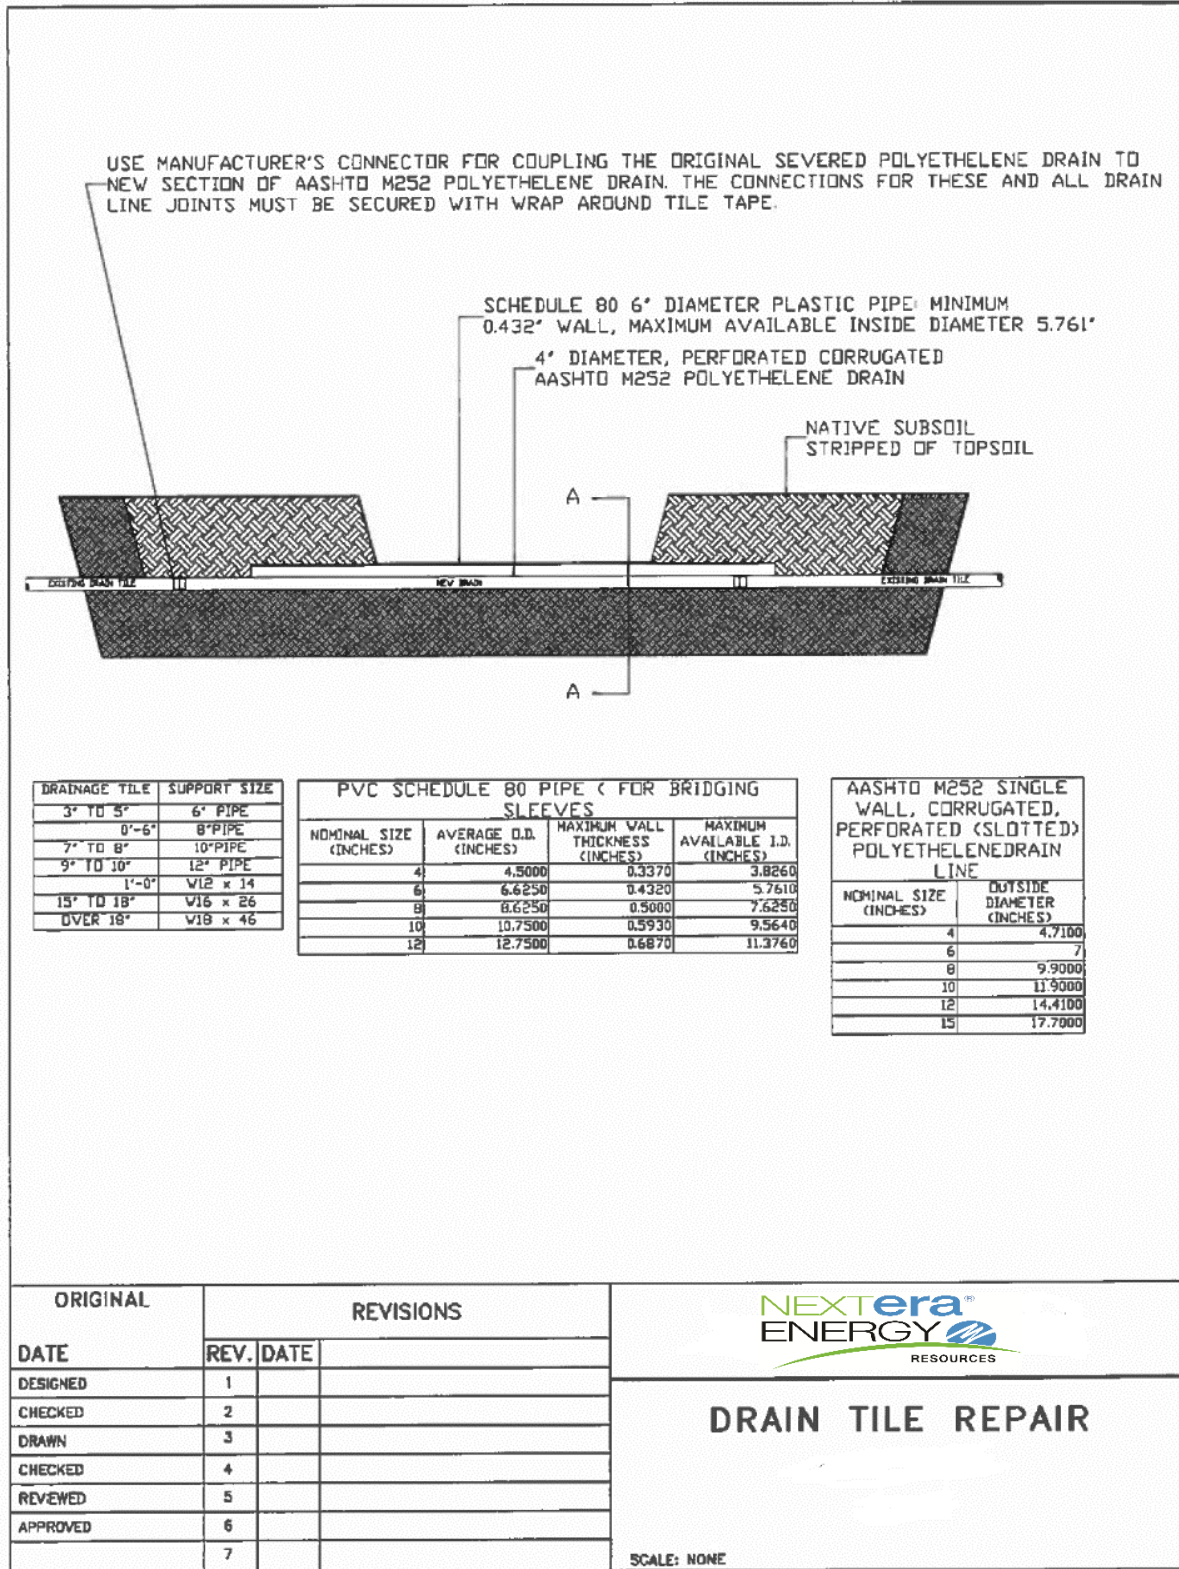
A schematic of the drain tile repair specifications is provided below.

In agricultural areas where construction activities result in damage to drain tile, as observed through visual inspection and/or communication with the farm owner/operator, NEETNY will repair the drain tile in accordance with the Natural Resources Conservation Service Practice Standards for subsurface drainage tiles and following Code 606 standards. All new plastic drain tubing will meet or exceed the American Association of State Highway and Transportation M252 specifications.
